# *Trademark Home Inspection Co.*

## Property Inspection Report

1035 Chateau Forrest Rd., SAMPLE, GA 12456

Date of Inspection: 3/21/2016 Time: 10 am

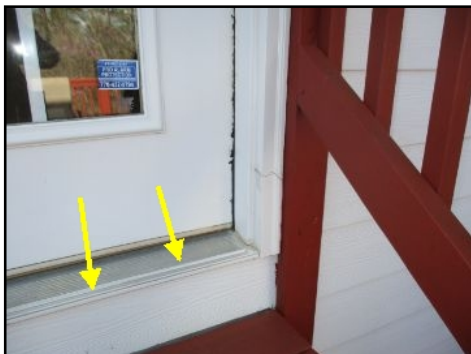
SAFETY CONCERN: The master bedroom exterior door threshold has a lip that could be a trip hazard

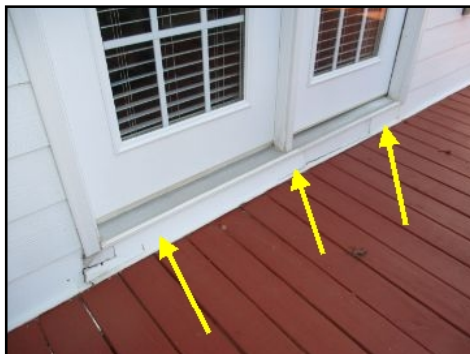
Recommend adding a kick plate to under threshold to prevent threshold damage

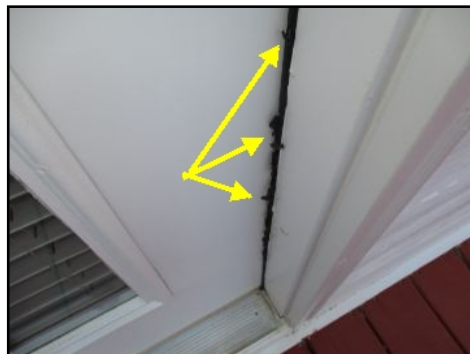
Minor repair needed- pet damage observed at several exterior door weatherstripping

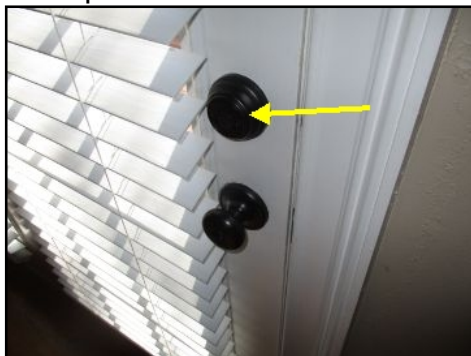
Emergency Egress Concern. Exterior door(s) have a double-sided keyed dead bolt lock set. This type of lock requires a key to unlock the door from the inside and can present an obstacle to anyone trying to evacuate the home in the event of a fire.

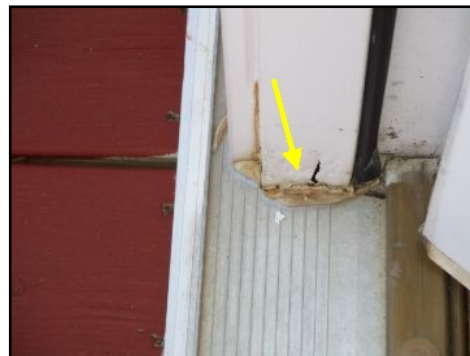
Wood deterioration observed, wood rot in trim around door jams. Suggest repairs/replacement as needed.

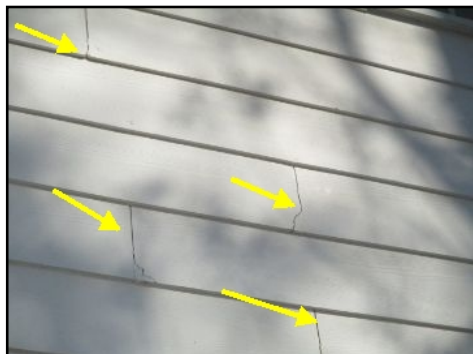
Caulk and seal all gaps, cracks and openings. Siding has several breaks due to improper install of hardi-board siding and gaps where siding has contracted after install

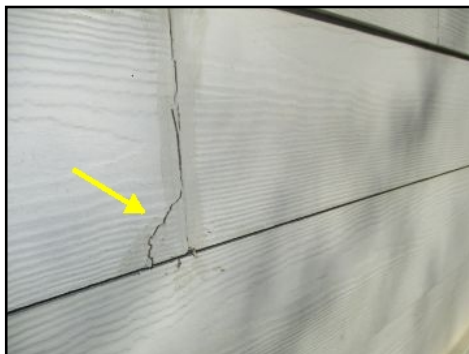
Caulk and seal all gaps, cracks and openings. Siding has several breaks due to improper install of hardi-board siding and gaps where siding has contracted after install

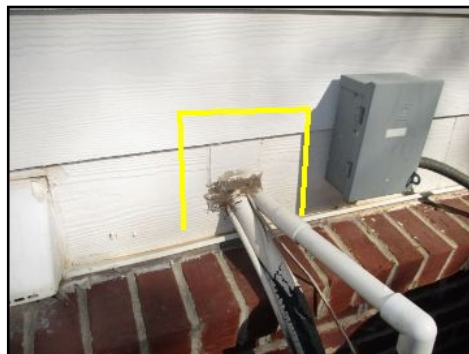
Recommend a vent cover be added to protect penetrations

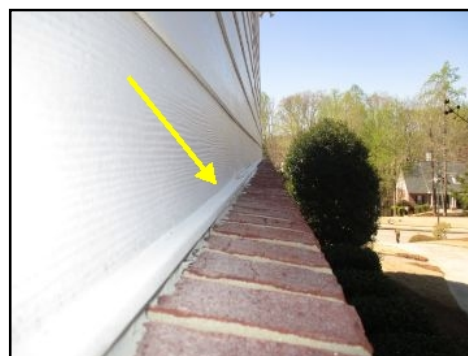
The rain cap between the brick and the start of siding has a negative slope allowing water to intrude the home. Recommend repair/ replacement with proper slope to allow the cap to properly shed water. NOTE: The interior basement wall is saturated in this location ( see BASEMENT WALLS section for details)

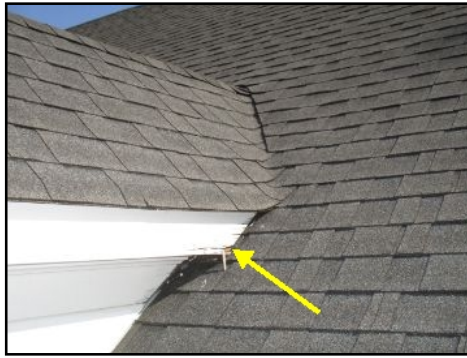
Moisture damage, wood rot, observed. Recommend review for repair as necessary.

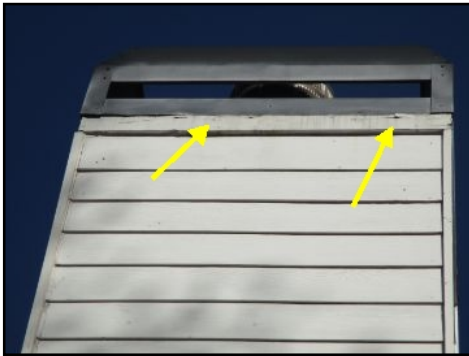
Weathered wood surfaces observed at chimney trim. Wood deterioration and rot can occur. Prep, prime and paint wood trim as needed.

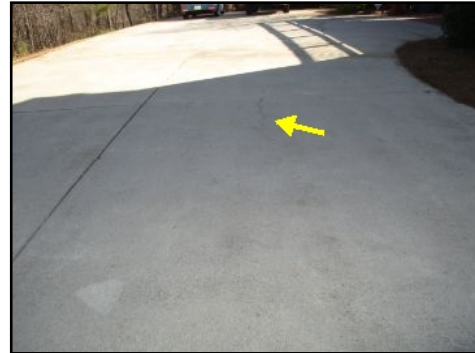
Driveway in good shape for age and wear. Minor and typical cracks. Recommend sealing to prevent expansion

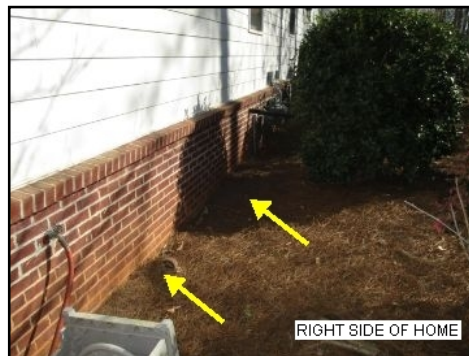
The exterior grading is improperly sloped towards the foundation on the right side of the home. Water can intrude into the interior. Recommend creating the proper slope away from the foundation to allow for proper drainage.

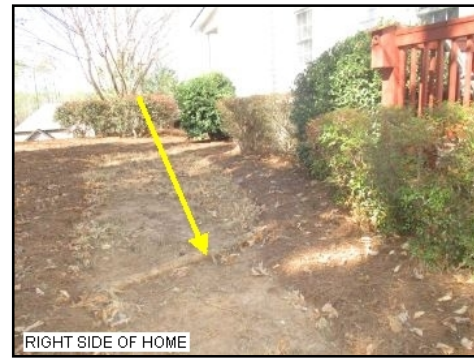
Recommend cutting or removing roots that are too close to foundation wall

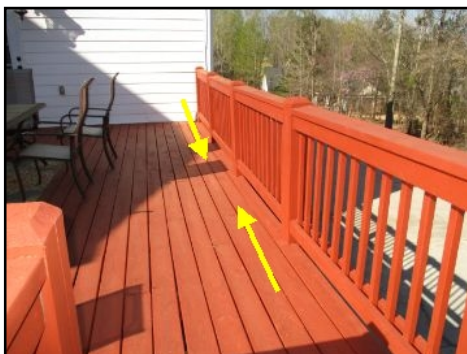
Rear deck over carport is sagging and requires additional support. Recommend a licensed contractor to evaluate further and make corrective repairs

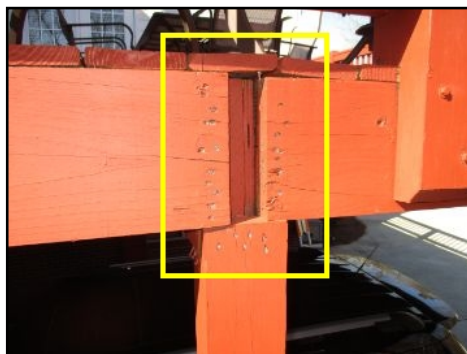
Rear deck supports require post to beam connectors or simpson ties to secure attachment and prevent warping supports to twist and turn.

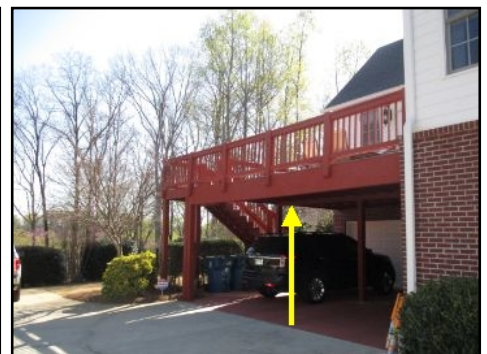
Rear deck over carport is sagging and requires additional support. Recommend a licensed contractor to evaluate further and make corrective repairs

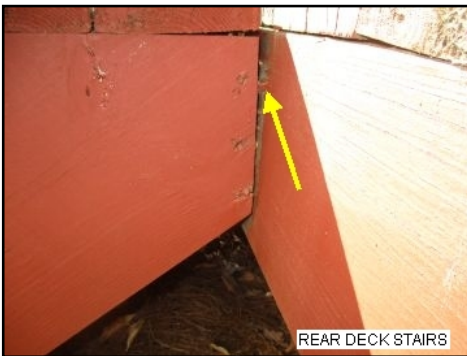
Recommend adding additional support to stair strings where stairs attach to deck.

Recommend adding stair stringer joist hangers

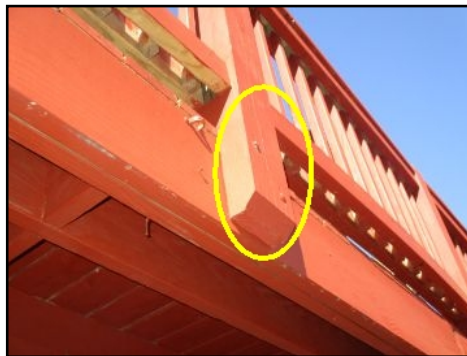
Deck major guard rails are screwed in and not properly secure with lag bots

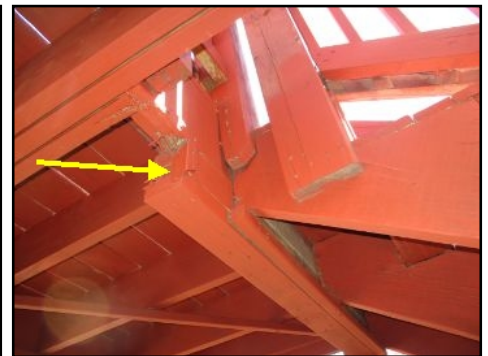
Recommend adding additional support to stair strings where stairs attach to deck. Recommend adding stair stringer joist hangers

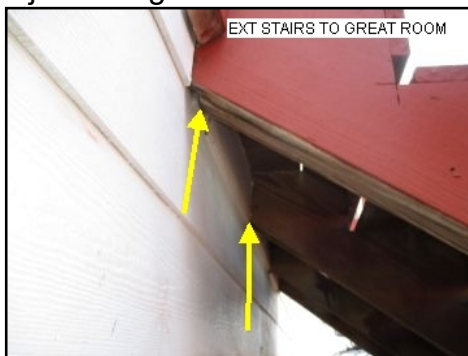
Recommend adding additional support to stair strings where stairs attach to deck. Recommend adding stair stringer joist hangers

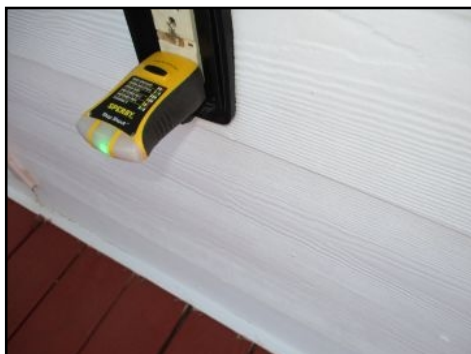
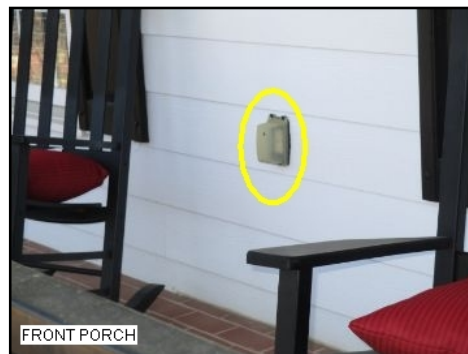
Several exterior "patio,porch" outlets ( GFCI) did not shut of when tested, have a qualified electrician replace for safety

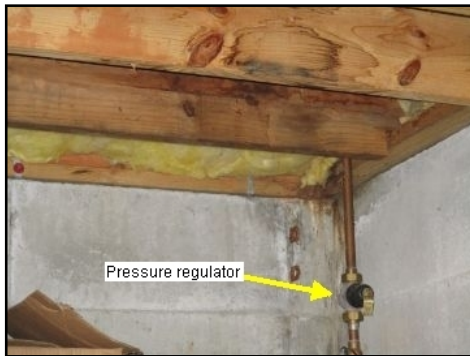
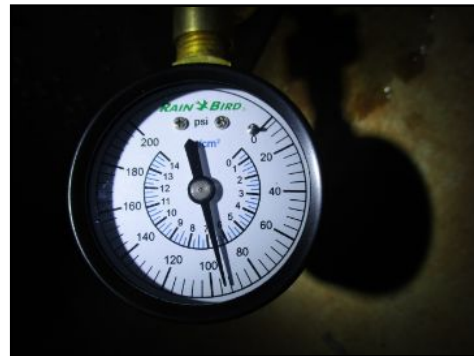
- High pressure.90+ psi noted. Recommend a licensed plumber to adjust pressure regulator.

Pressure regulator noted. Basement

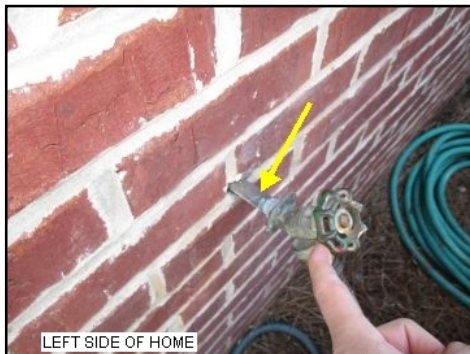
Exterior hose bib is not properly secure to the structure

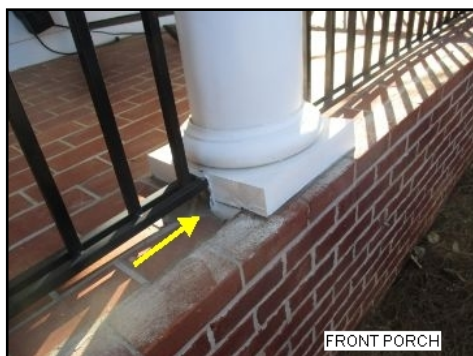
FRONT PORCH

Front porch is built over/inside the homes foundation walls. Porch surface has failed and is sagging allowing water to intrude foundation. Recommend a licensed contractor to evaluate further and make repairs as needed. Note: Significant settling is due to a lack of column support and moisture deteriorated wood below. It is advised to have a structural engineer design or approve plans for repair

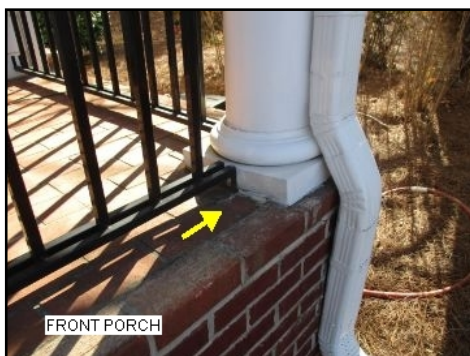
FRONT PORCH

Front porch is built over/inside the homes foundation walls. Porch surface has failed and is sagging allowing water to intrude foundation. Recommend a licensed contractor to evaluate further and make repairs as needed. Note: Significant settling is due to a lack of column support and moisture deteriorated wood below. It is advised to have a structural engineer design or approve plans for repair

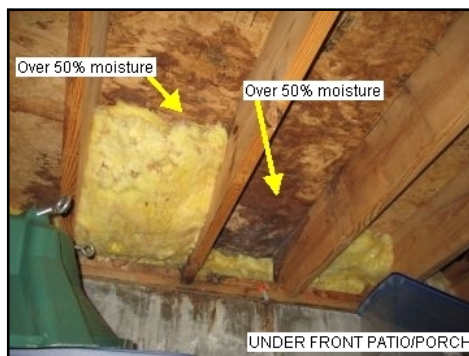
UNDER FRONT PATIO/PORCH

Front porch is built over/inside the homes foundation walls. Porch surface has failed and is sagging allowing water to intrude foundation. Recommend a licensed contractor to evaluate further and make repairs as needed. Note: Significant settling is due to a lack of column support and moisture deteriorated wood below. It is advised to have a structural engineer design or approve plans for repair

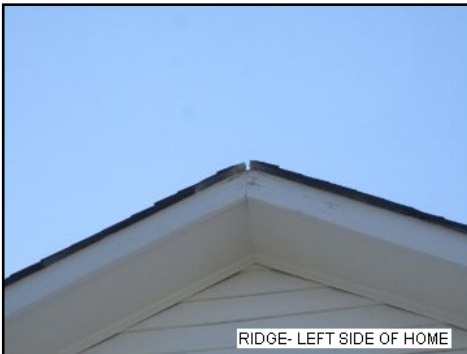
Ridge cap: deteriorated or missing shingles. Replacement of shingle required

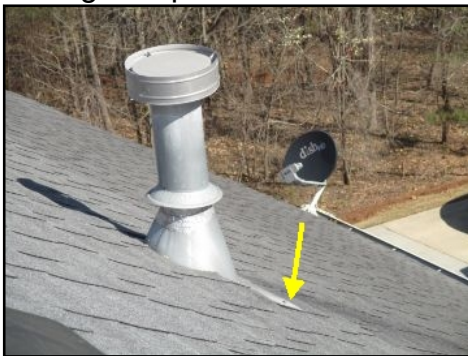
Recommend sealing all exposed nail heads

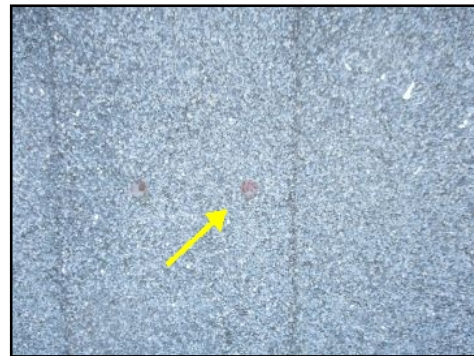
Exposed nails on roofing material. Recommend sealing all fastener heads.

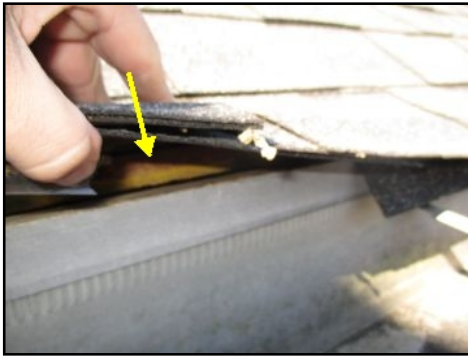
No drip edge flashings leave underlying framing exposed to weather. This condition may result in deterioration of home materials from moisture intrusion. The Inspector recommends missing flashing be replaced by a qualified contractor.

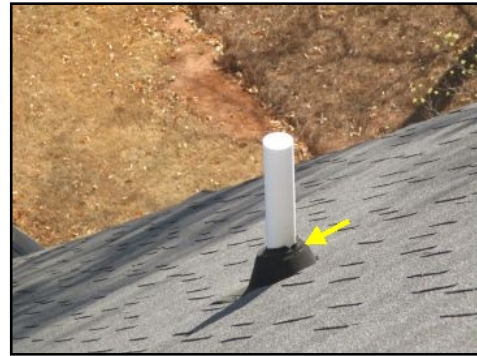
Recommend sealing all plumbing boots , although no leaks or daylight visible these seals weather quickly

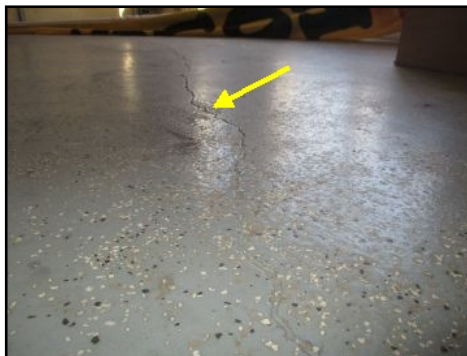
Cracks observed. Recommend monitoring for further expansion

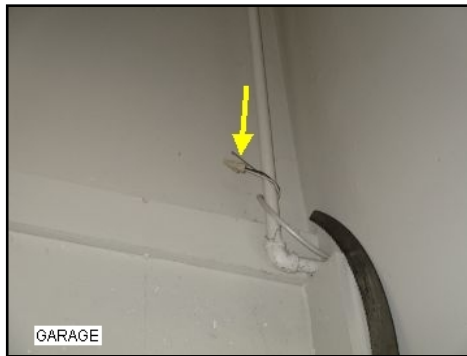
Exposed electrical wires observed in garage , recommend placing loose wiring inside a junction box

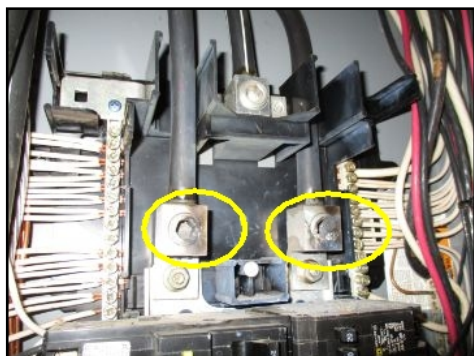
Burn marks observed on 2 mains. Recommend professional evaluation and any repairs needed by a licensed electrician. Note: infrared camera did not detect excessive heat in this location at time of inspection

Questionable wiring in panel box. 1) Sub - Neutral wires improperly double tapped on bus bar Have licensed electrician evaluate and run neutral wires to a dedicated slot on bus bar.

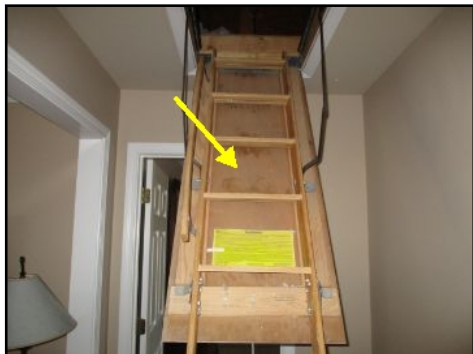
IMPROVE: The attic access is not insulated. Expect some energy loss through convection. Recommend insulating attic access walk in door

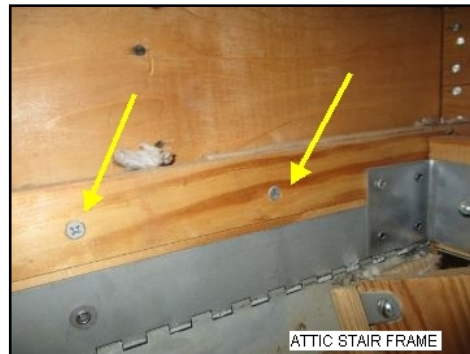
Attc access frame door has improper fasteners. Frame install instructions required 16 D nails

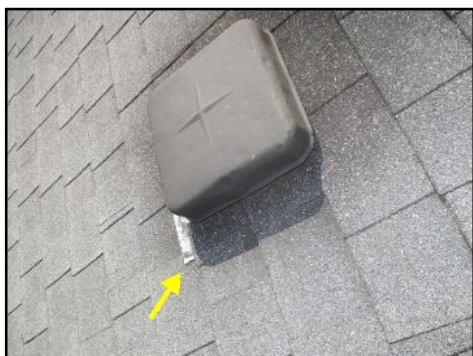
Recommend sealing all exposed nails heads to prevent leaking

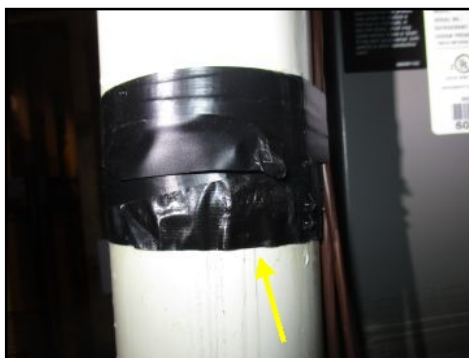
**\*\*VENTING OBSERVATIONS\*\*** Vent pipe PVC in basemen is leaking. Nonprofessional repair observed

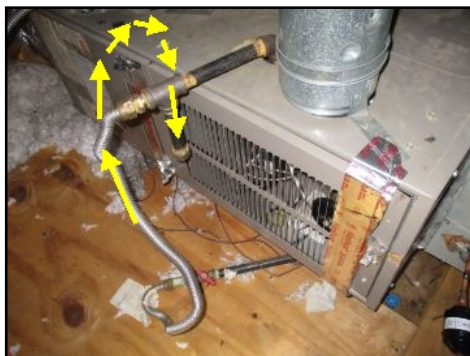
Attic Gas line to furnace is improperly installed. Gas line is installed such that gas by-passes sediment trap. Recommend a licensed HVAC professional to evaluate further and make corrective repair

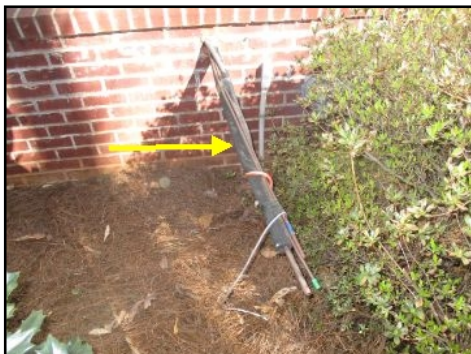
Recommend removal of old refrigerant lines and seal hole at structure

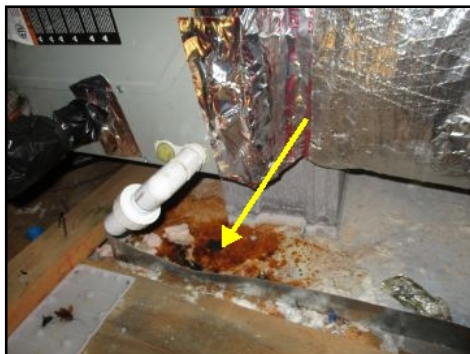
Minor rust from past leak in attic furnace drain pan

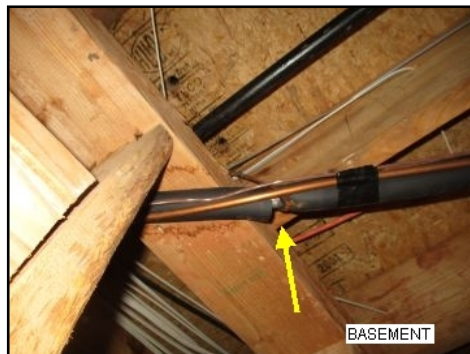
Missing insulation /Gaps in insulation observed in the basement

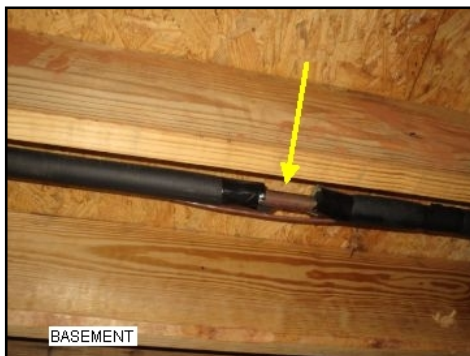
Missing insulation /Gaps in insulation observed in the basement

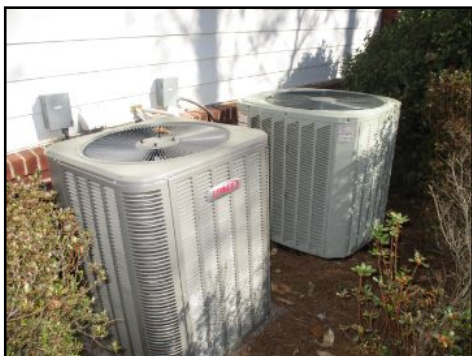
Exterior units not level. This can affect system performance. Recommend making all units level

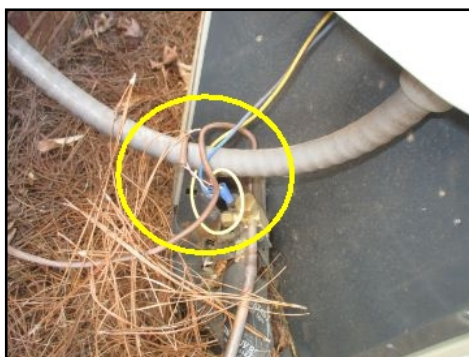
Exposed wires observed outside the AC unit - \*All wiring should be placed on interior of unit

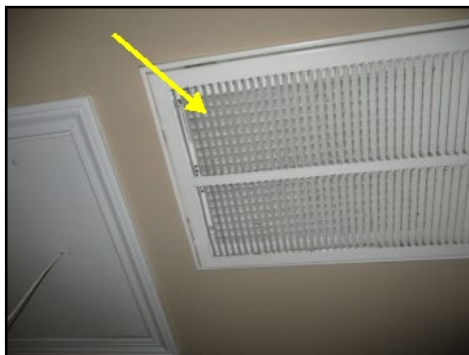
Furnace filter dirty. Needs replacement. 14x20x1

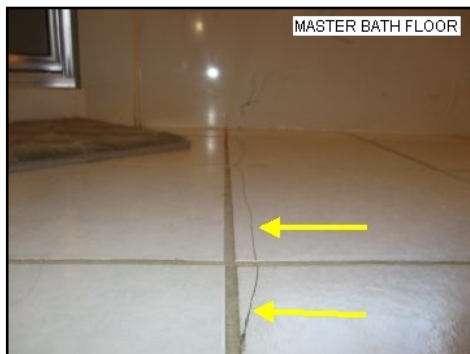
Master bathroom floor is not level and appears to have sagged since original construction. Note: Tile is cracked in master bath

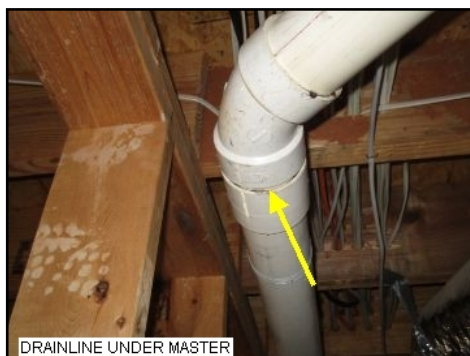
Visible leaking noted under the master bathroom drain line located in the basement. Recommend contacting a licensed plumbing contractor for repair options and corrective repairs

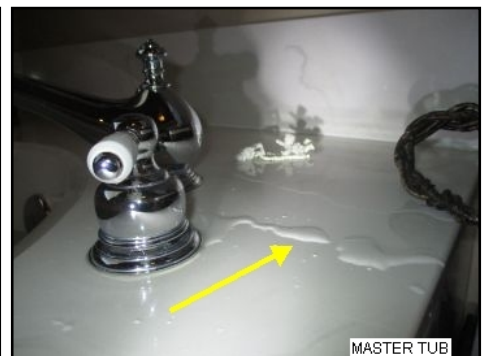
MASTER TUB

Master tub hardware leaks at base while in operation

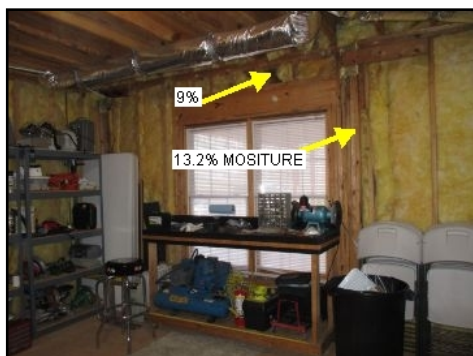
Active leaks observed at the time of inspection. Location: Under front porch and left side of structure

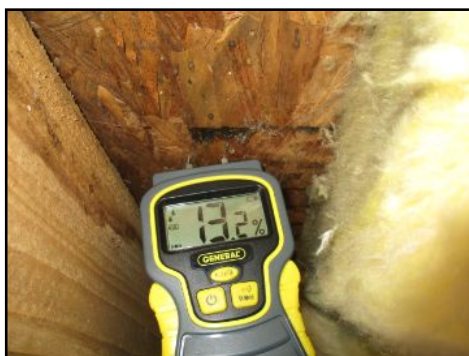
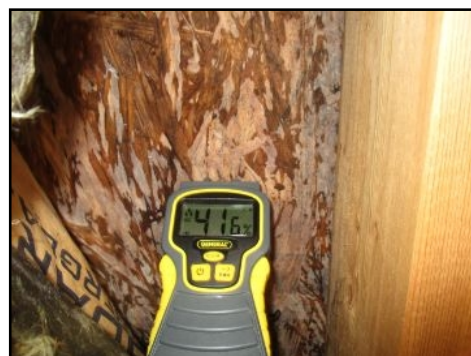
Active leaks observed at the time of inspection. Location: Under front porch and left side of structure

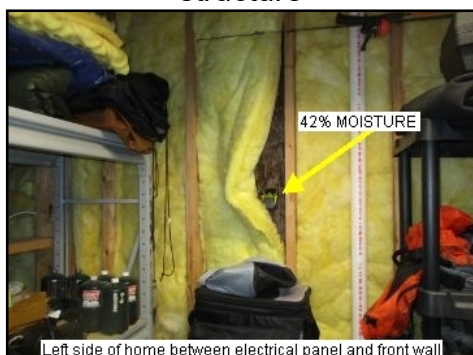
Active leaks observed at the time of inspection. Location: Under front porch and left side of structure

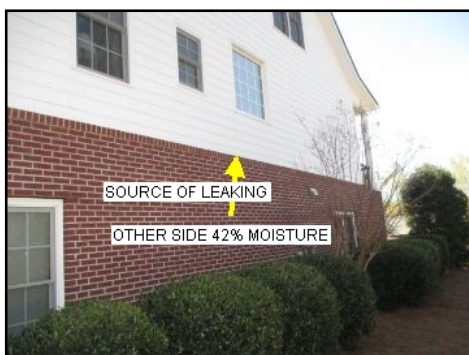
Active leaks observed at the time of inspection. Location: Under front porch and left side of structure

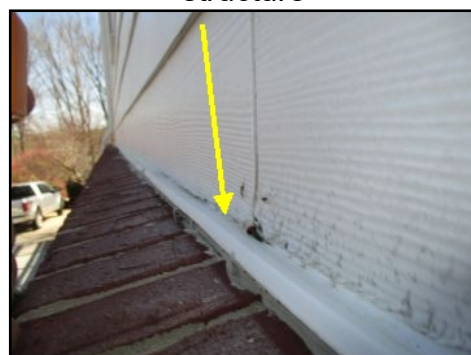
Active leaks observed at the time of inspection. Location: Under front porch and left side of structure . Source of interior basement wall leaks

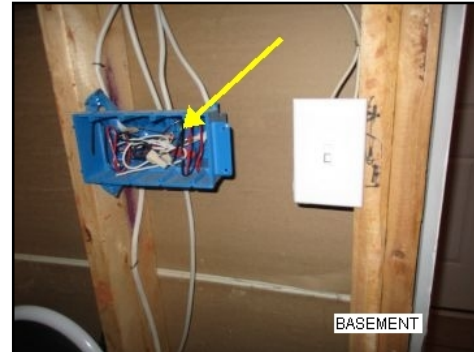
Missing outlet covers/and or missing junction box cover plates - throughout basement. Recommend cover plates for safety See pictures.
