# *Trademark Home Inspection Co.*

## Property Inspection Report

1035 Chateau Forrest Rd., SAMPLE, GA 12456

Date of Inspection: 3/21/2016 Time: 10 am

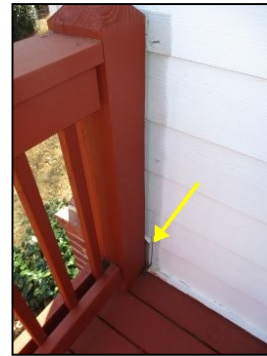
Finish worked is required at siding

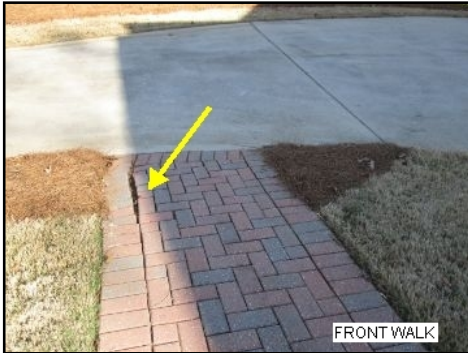
Minor settling under front brick paver walk

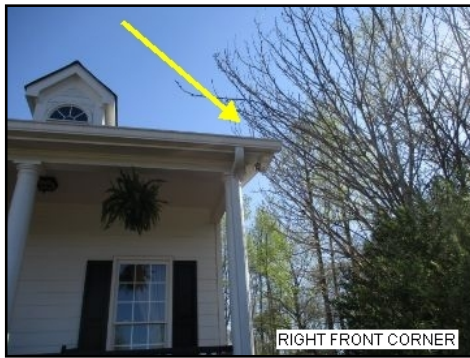
Tree limbs within 10 feet of roofline should be trimmed away to provide air and sunlight to roof, while minimizing debris & dampness. This will also reduce the risk of wildlife and pests entering structure

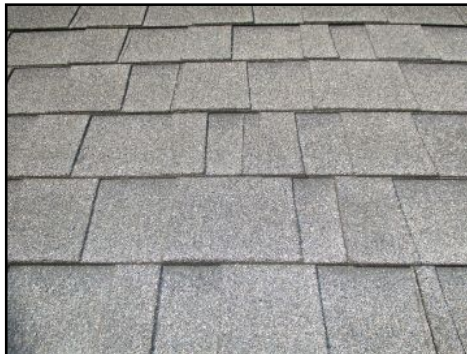
Very good granular life remaining on roofing material

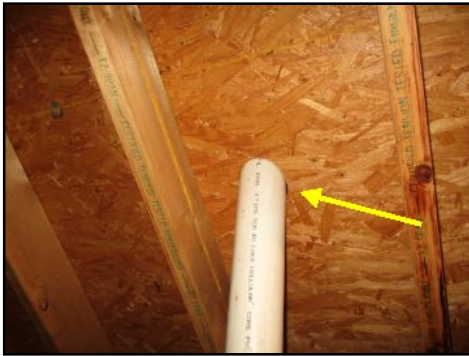
No leaks observed around plumbing boots/vent cap

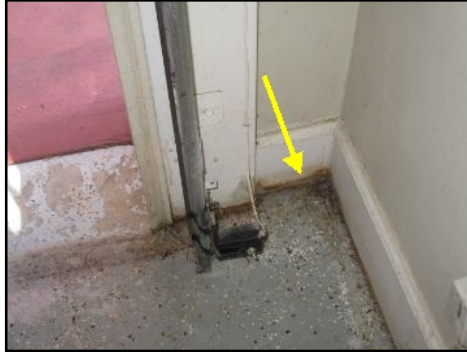
Minor water intrusion observed on interior garage walls/baseboard

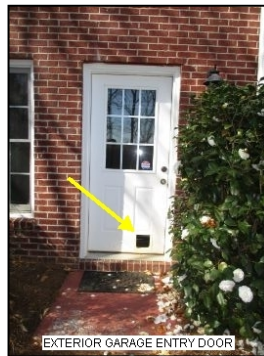
Recommend adding a cover over pet door

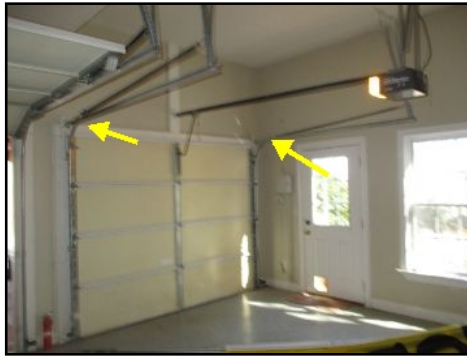
The garage door appeared functional during the inspection. - Recommend lubricating doors for reduction of friction and squeaks

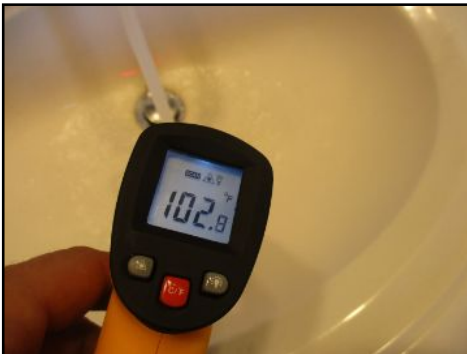
Tanks appear to be in satisfactory condition -- no concerns.

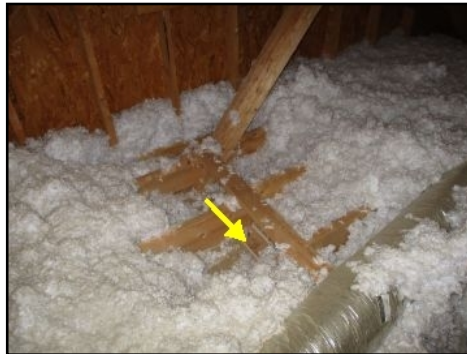
Insulation appears inadequate/sparse in some areas. Insulation depth is less than 8 in several areas. Recommend adding insulation to achieve a consistent R-30 Value/ or 13+ inches

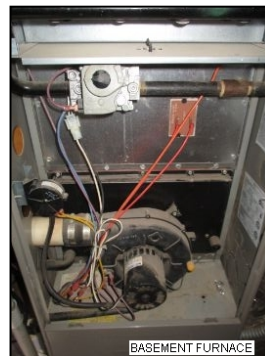
Basement furnace enclosure is clean for age of unit - Minor rust and scale

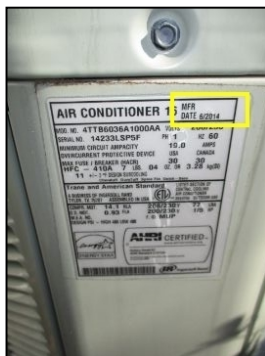
AC data plate , Brand Trane , Age 2015, 3 ton unit. Note: This unit appears to be too large for the amount of conditioned space it serves

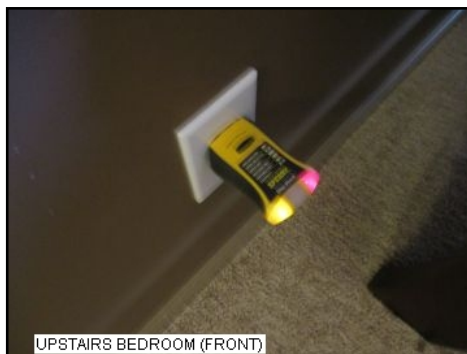
UPSTAIRS BEDROOM (FRONT)

Several interior outlets failed when tested. Upstairs secondary outlet appears to be wired incorrectly and the main level office ?(First room on left) several outlets failed when tested. Recommend professional evaluation and replacement or repair of these outlets

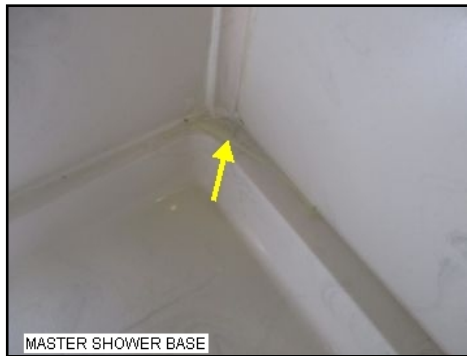
MASTER SHOWER BASE

**\*\*SHOWER BASE\*\*** pan appears to be cracked. Repairs observed however it is advised to seek further evaluation form a licensed plumber or contractor

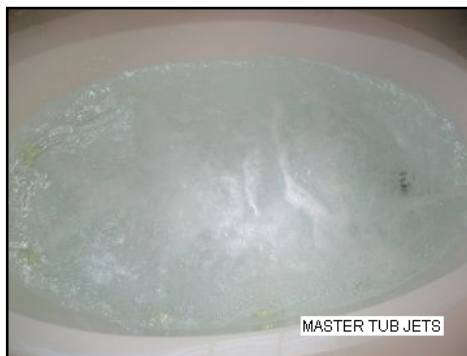
MASTER TUB JETS

Jets tested and functional

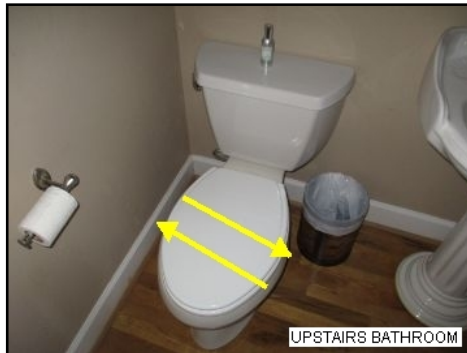
- Toilet loose and may need re-anchoring. Upstairs bathroom

Toilet loose and may need re-anchoring. Upstairs bathroom

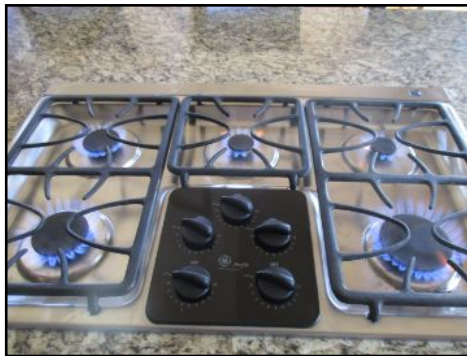
Tested and functional

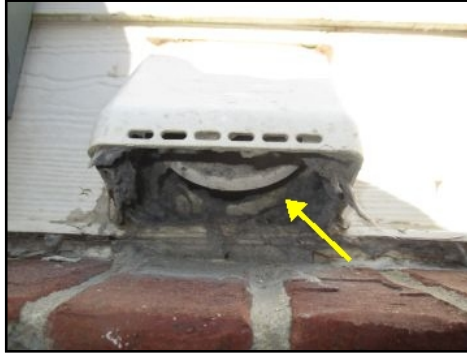
- *The dryer vent has a damaged or clogged exterior cover. Recommend repair or cleaning to prevent a fire hazard*

The dryer vent has a damaged or clogged exterior cover. Recommend repair or cleaning to prevent a fire hazard
